# RVSD Asset Management In the field

**Ross Valley Sanitary District**

- 194 mi Gravity Sewer
- Over 15,000 EDU's
- 200 mi Private Laterals
- 73% 6 inch Pipe or smaller
- 40% of Pipe on Easements
- 5,200+ Manholes or Rod Holes

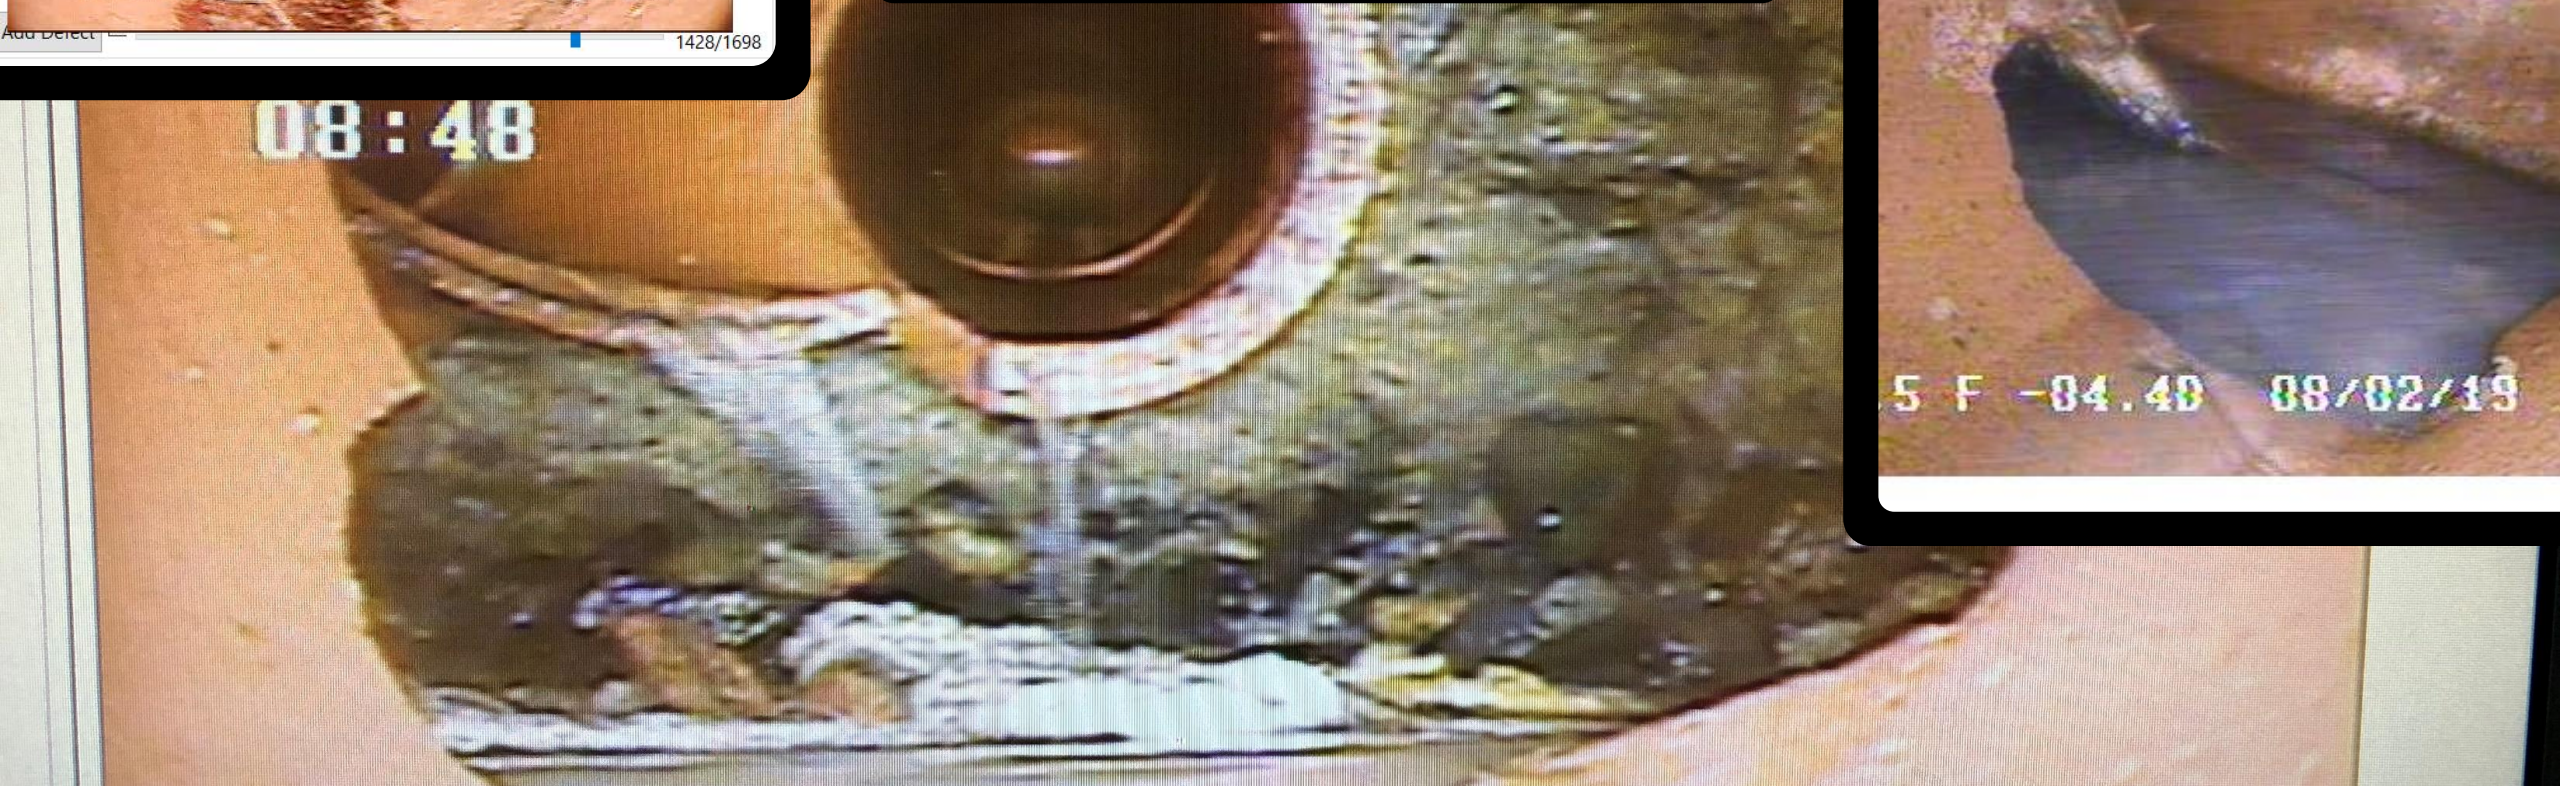
Incident Description: Obstacle -  
Object Protruding Thru Wall  
Position: 9  
Comments: waterline  
Percentage: 50

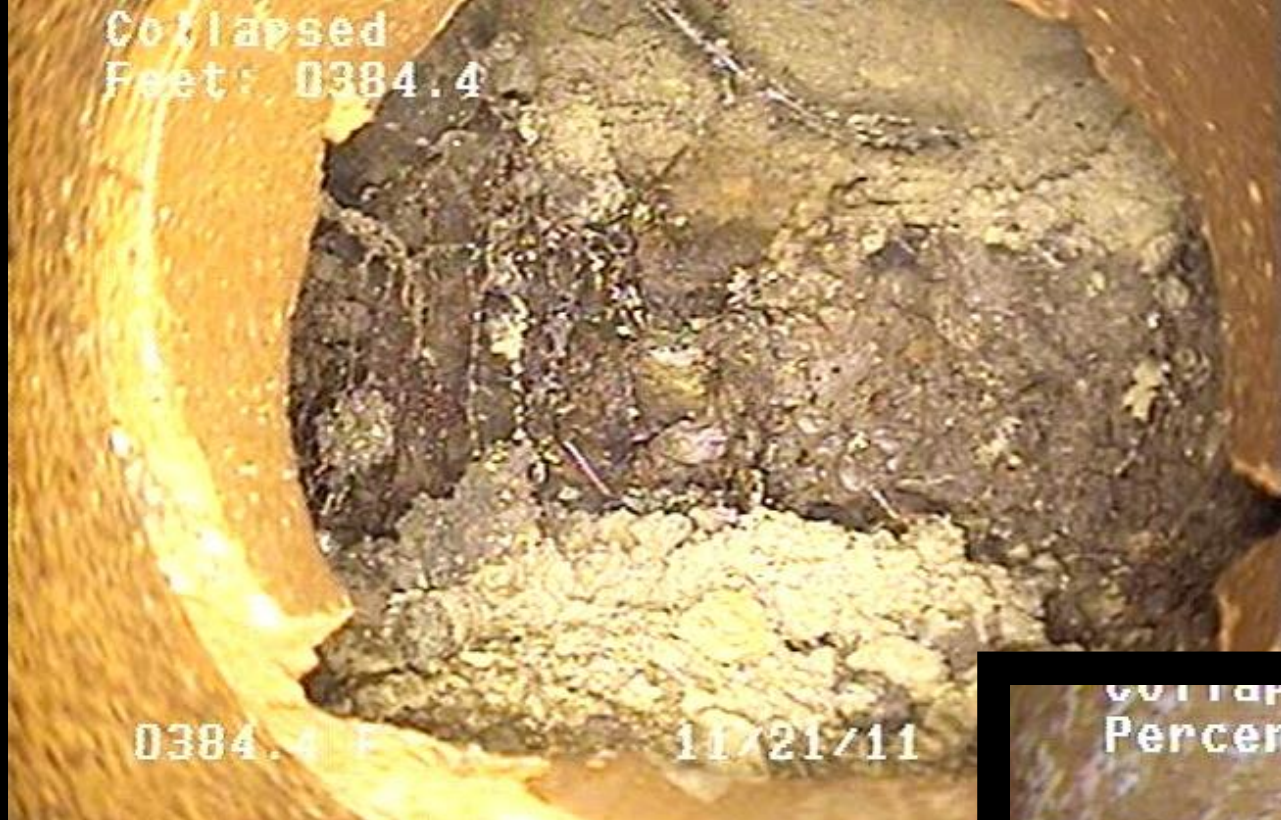
Collapsed  
Feet: 0384.4

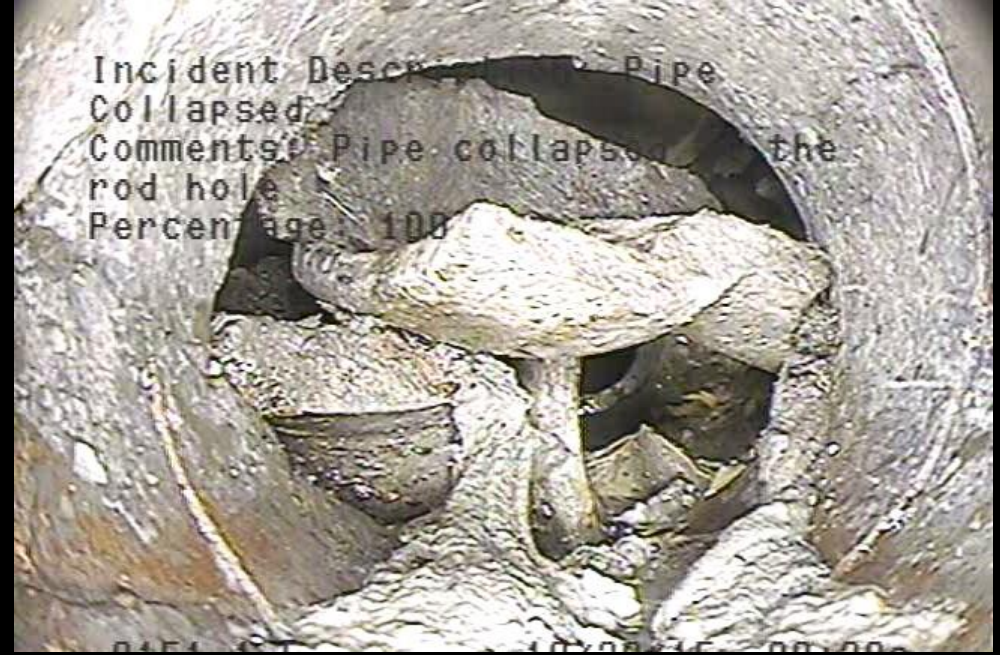
Incident Description: Pipe  
Collapsed  
Comments: Pipe collapsed the  
rod hole  
Percentage: 100
